DIAMOND WIRE – STONE INTERACTION DURING THE CUTTING PROCESS: MECHANICAL,
PHYSICAL AND CHEMICAL INVESTIGATIONS

DIAMOND WIRE – STONE INTERACTION DURING CUTTING PROCESS: MECHANICAL, PHYSICAL AND CHEMICAL INVESTIGATIONS

S. Spriano¹, S. Ferraris¹, R. Bellopede², P. Marini², L. Zichella², A. Tori³

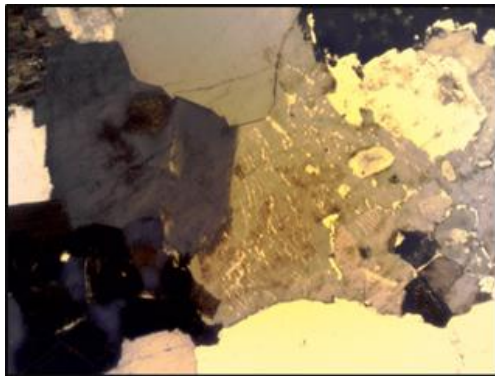
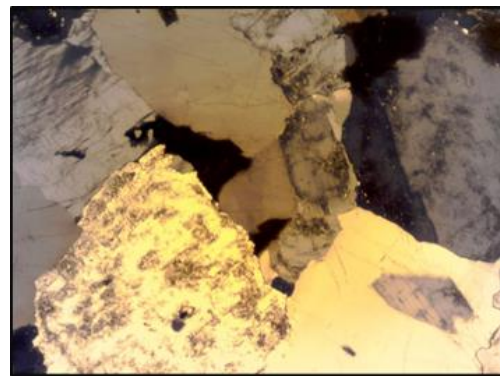
A. RG granite

B. GP granite

Figure 1: Thin sections of RG and GP granite (long side 4.3mm): microscopy crossed nicols, in black the ferrous components (biotite).

Petrographic analysis and mineralogical investigation have been performed on the stones and on the muds derived from their cutting. Both have been analyzed by means of the optical microscope Leitz Wetzlar. Image analyzer software IMAGE J (an open source image processing program designed for scientific multidimensional image), in order to define size, dimension and ratio between quartz and feldspar. In

Figure 1 the thin sections of two different kind of Sardinian granite (RG and GP) are reported.

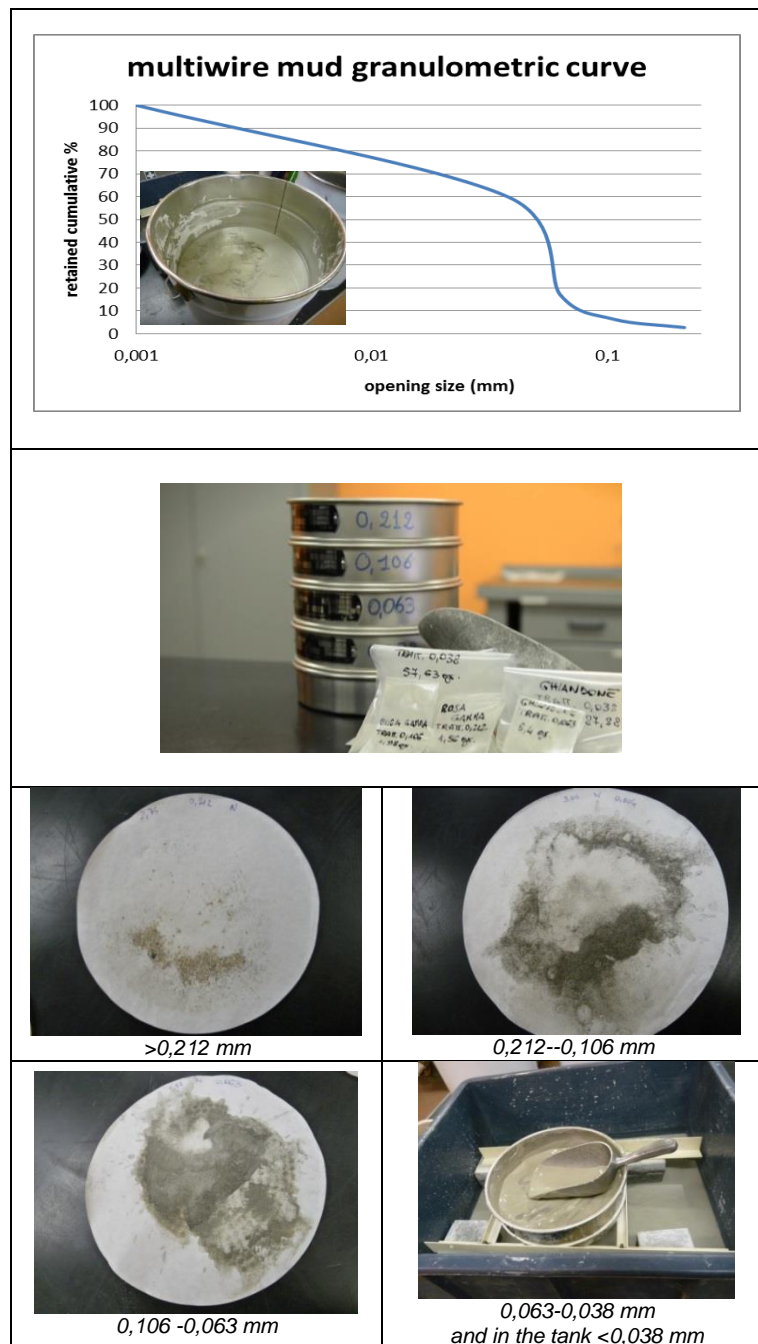
The granulometric curve of multiwire muds is shown in Figure 2; it is characterized by an high percentage (40.2%) of particles minor than 0,038mm.

Figure 2: size distribution process and characterization of multiwire muds

Each one of the classes obtained through the granulometric separation has been processed with a wet magnetic separation (Co-Al – Ni magnet). On the size classes minor than 0,063mm a further analysis by means of X – Ray Diffraction (XRD) have been performed.

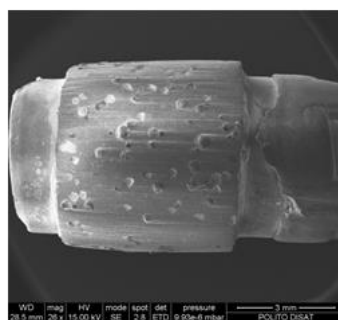
As first, we observed at low magnification that the beads almost maintain their shape after stone cutting and they are almost uniformly worn (see Figure 4) on all their length. The direction of cutting and rotation of the diamond wire can be derived by observing the presence of “comet tails” behind the diamond grits and the slight lower diameter of the bead on the left of the image: the first impact of the bead with the stone during cutting was on the left side, in this case.

Figure 4: SEM image at low magnification of a worn diamond bead

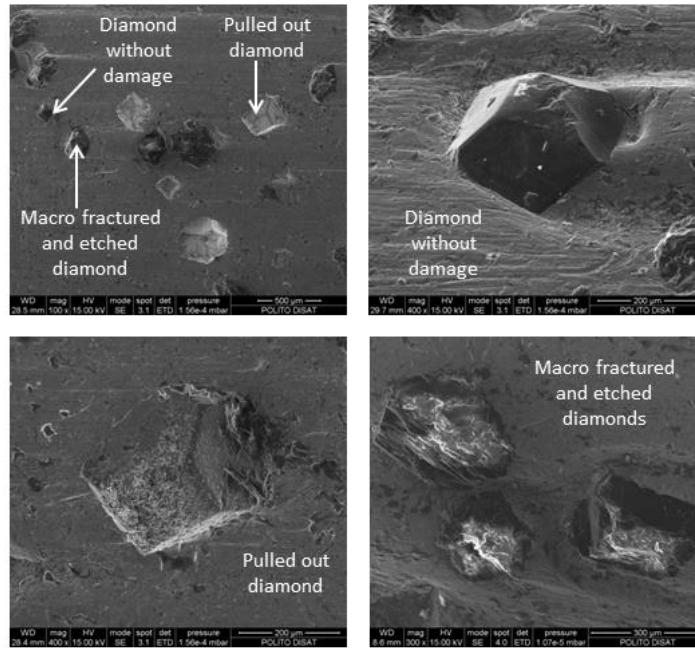
In this case, we observed diamonds arising from the surface without any damage, macro fractured, pulled out and etched (Figure 5).

Figure 5: Image of the surface of a worn diamond bead with diamond bits differently damaged

Diamonds without any damage are diamonds still able to cut stones and a “comet tail” is clearly visible behind them, because their presence prevent erosion of the metal matrix behind them by stone debris, during cutting. [8] The interface between the un-damaged diamond bits and the metal matrix is continuous and without any cracks, showing a high retention ability of the metal matrix and good sintering of the beads. [9] EDS analysis performed on the smooth surface of the un-damaged diamonds only shows the presence of carbon.

Some diamonds were pulled out during cutting and some voids are observable on the surface; the voids are often quite deep, showing that in these cases diamonds were pulled out before they were highly worn. The EDS analysis performed inside the voids deriving from pulled out diamonds shows the presence of Co and WC, which are the main components of the matrix. No porosity can be seen inside the voids of the pulled out diamonds, confirming a good sintering of the metal matrix.

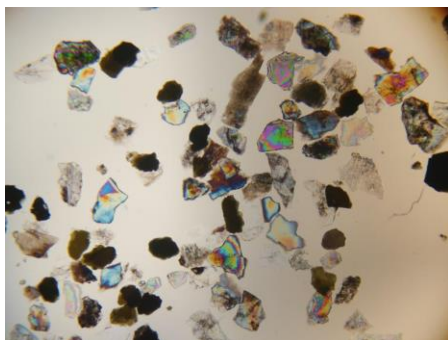
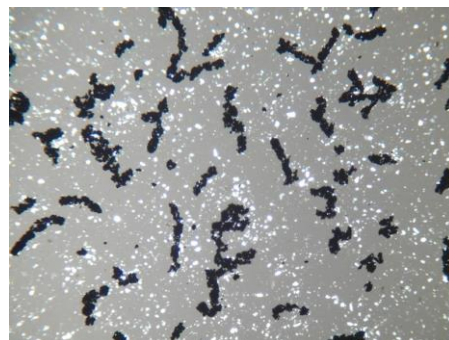
Figure 8: On the left micro-photo (6.9x5,19mm) with crossed nicols of mud particles >0.212mm and on the right micro photo (10.6 x 8mm)with parallel nicols of mud particles between 0.038-0.063mm.

Muds generated by stone cutting are mainly composed by stones debris and fraction of heavy metals (e.g. Co, Ni, Cu, Zn, Cr, W and their alloys) deriving from metal matrix. In particular, the magnetic separation shows, in the 0,038mm-0,063mm class, a higher amount of ferromagnetic particles coming from the metal matrix erosion, while, in the fine class (<0,038mm) the rock minerals (quartz in particular) are predominant: this is confirmed from the diffractometric analysis too (Figure 8). The sawmill mud contains heavy metals coming from the sawing tools: an example of 4 different muds sample (M1-M2-M3-M4) is in

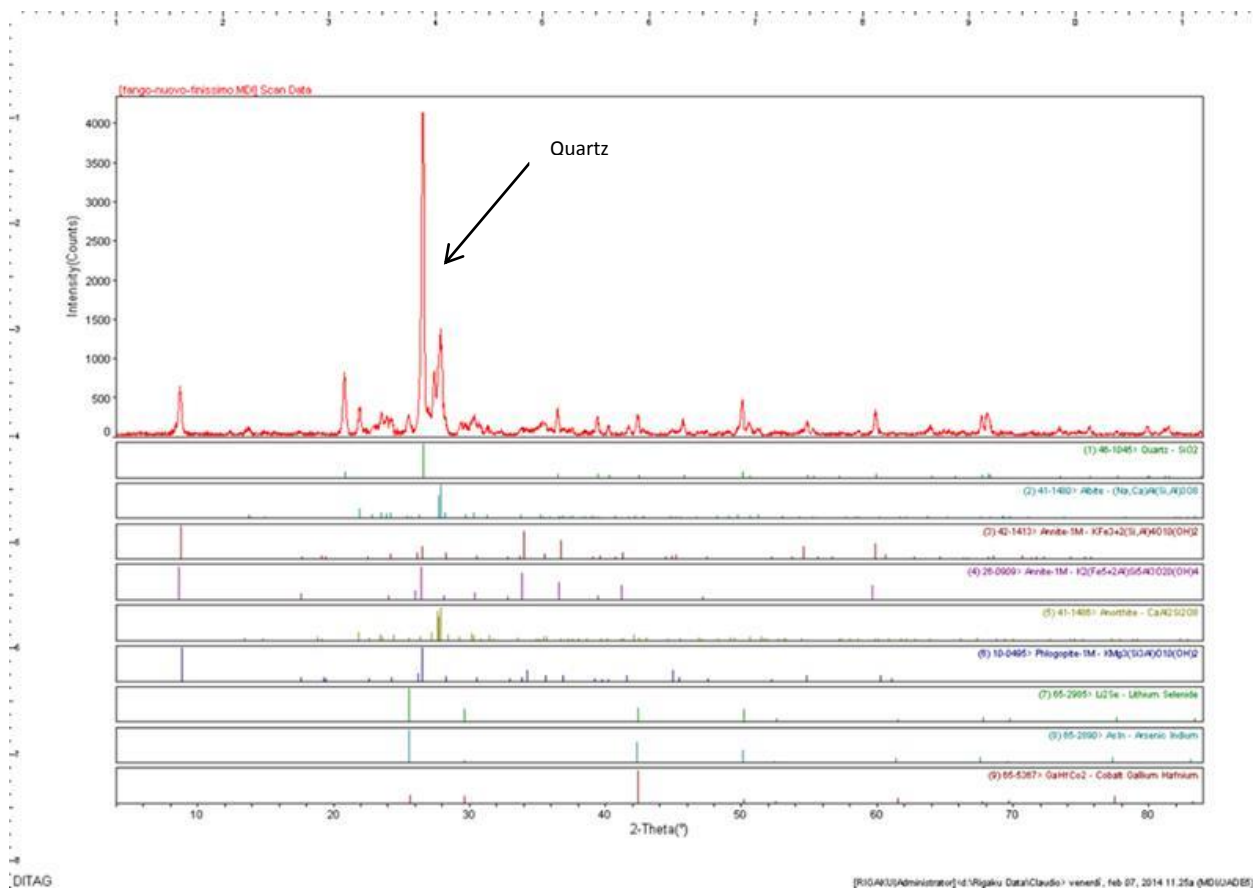
Figure 9: X- Ray Diffraction of muds <0,038 mm
